CASE STUDY

INDUSTRIAL HEAT EXCHANGER

120E-503 Regeneration Heater Data

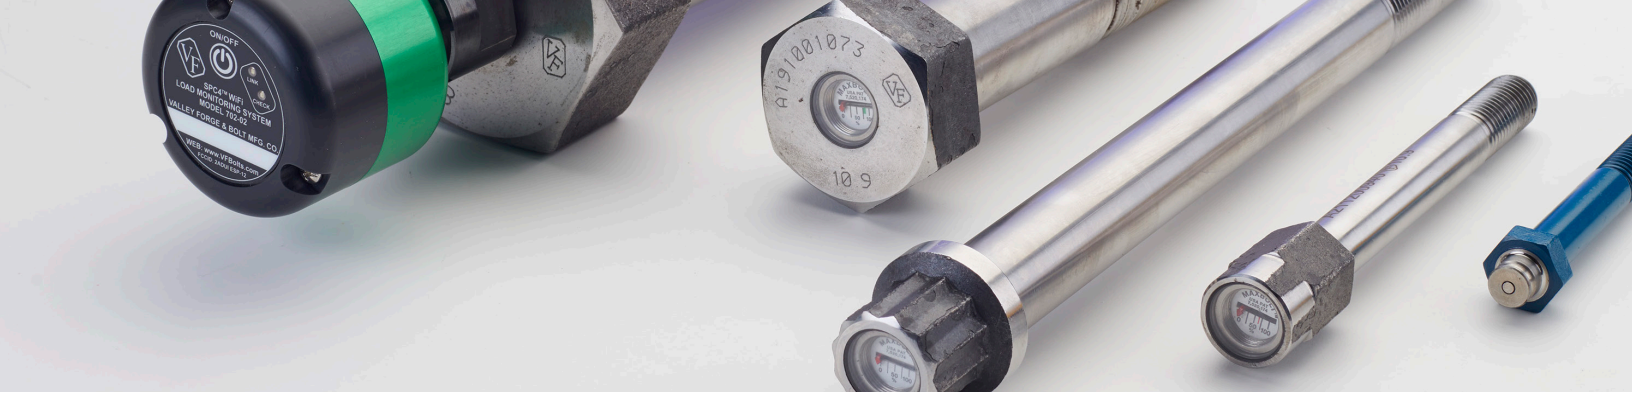
Fig. 1 - The installation method and solutions applied

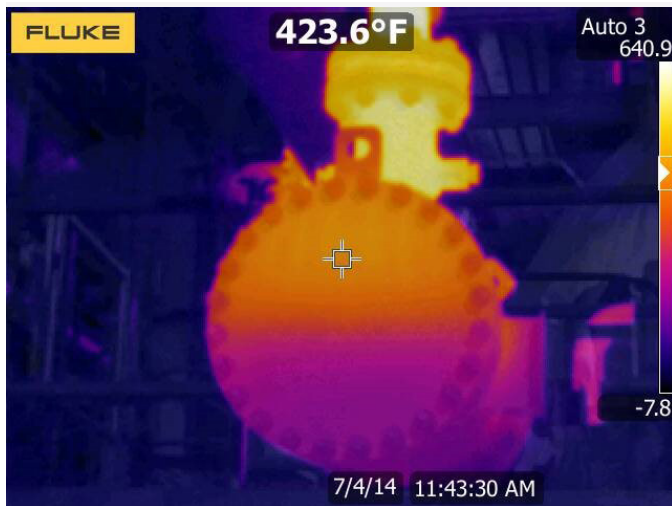
Fig. 2 - Shows where heat was leaking from the exchanger

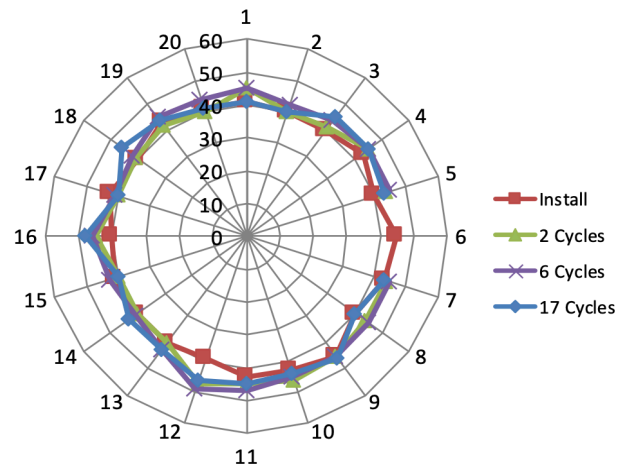
Fig. 3 - Spider graph showing tension during cycles

After 22 thermal cycles on this exchanger, unit does not leak anymore! In the 20 years prior to load indicating fastener installation, there had not been a single cycle without leakage. The cost* of fixing this leak issue on exchanger resulted in the amount of approximately \$213,000 savings.
